**Subject: Site Assessment Report
Lefton Iron & Metal Site
East St. Louis, St. Clair County, Illinois
Technical Direction Document No. S05-0108-036
Tetra Tech Contract No. 68-W-00-129**

**SITE ASSESSMENT REPORT
LEFTON IRON & METAL SITE
EAST ST. LOUIS, ST. CLAIR COUNTY, ILLINOIS**

TDD No.:	S05-0108-036
Date Prepared:	21Dec 01
Contract No.:	68-W-00-129
Prepared by:	Tetra Tech EM Inc.
START Project Manager:	Bryan L. Williams
Telephone No.:	(314) 892-6322, ext. 24
U.S. EPA On-Scene Coordinator:	Kevin Turner
Telephone No.:	(618) 997-0115

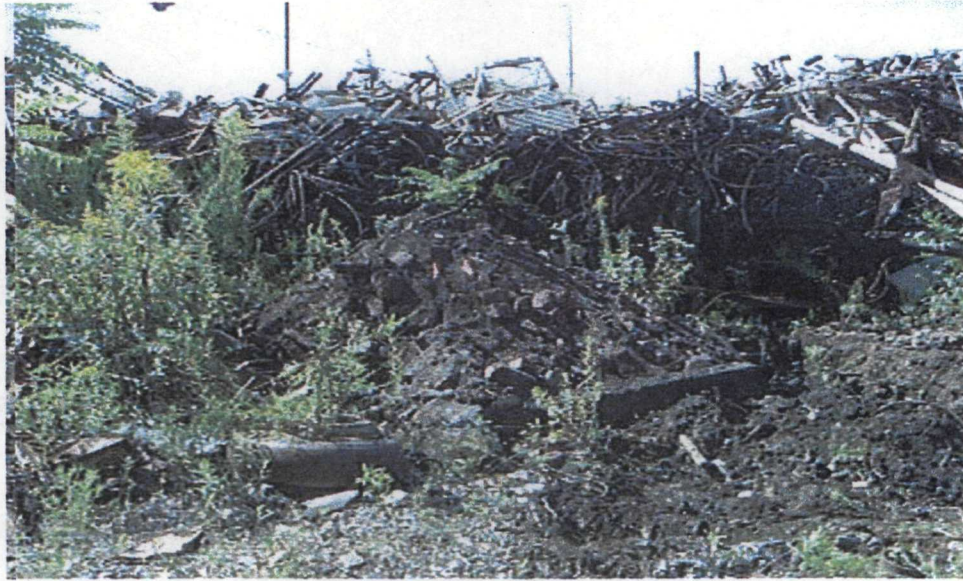
Scrap pile in Yard 1

START observed large piles of scrap and metal debris throughout the entire yard and three smaller buildings in the central portion of the parcel that housed pieces of equipment such as generators and heating and cooling equipment (Buildings 1 through 3). In addition, START observed transformer poles with fallen transformers near the buildings and an underground storage tank (UST) located along the northeastern fenceline.

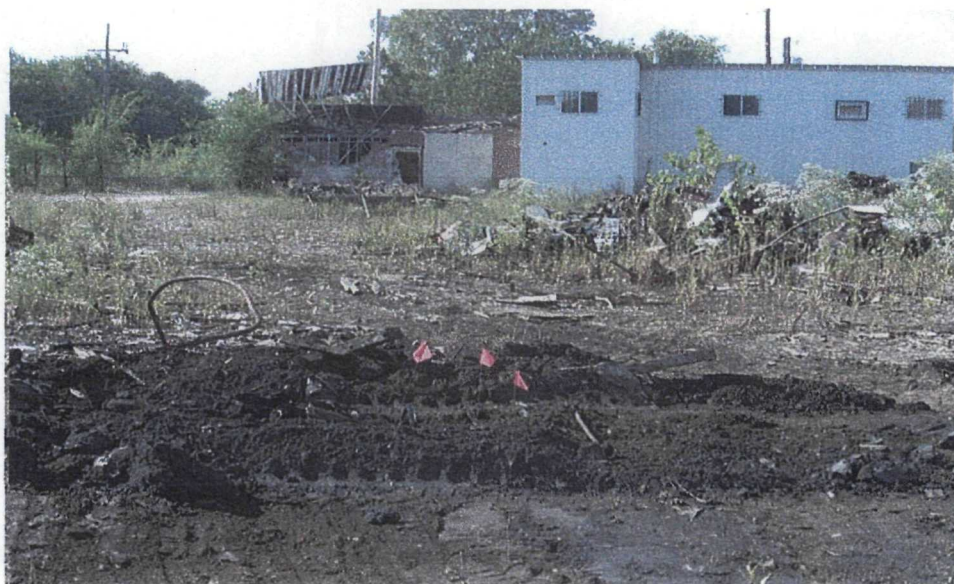
A small office building is located along the northwestern fenceline. Southwest of the building is a paved area, a weigh scale and gated entrance along the northwest fenceline near the southwest corner of the yard. START observed large piles of scrap and metal debris throughout the entire yard. In addition, START observed a pile of propane tanks, a fenced-in oxygen gas tank, and a small shed at Yard 2.

Scrap piles in Yard 2

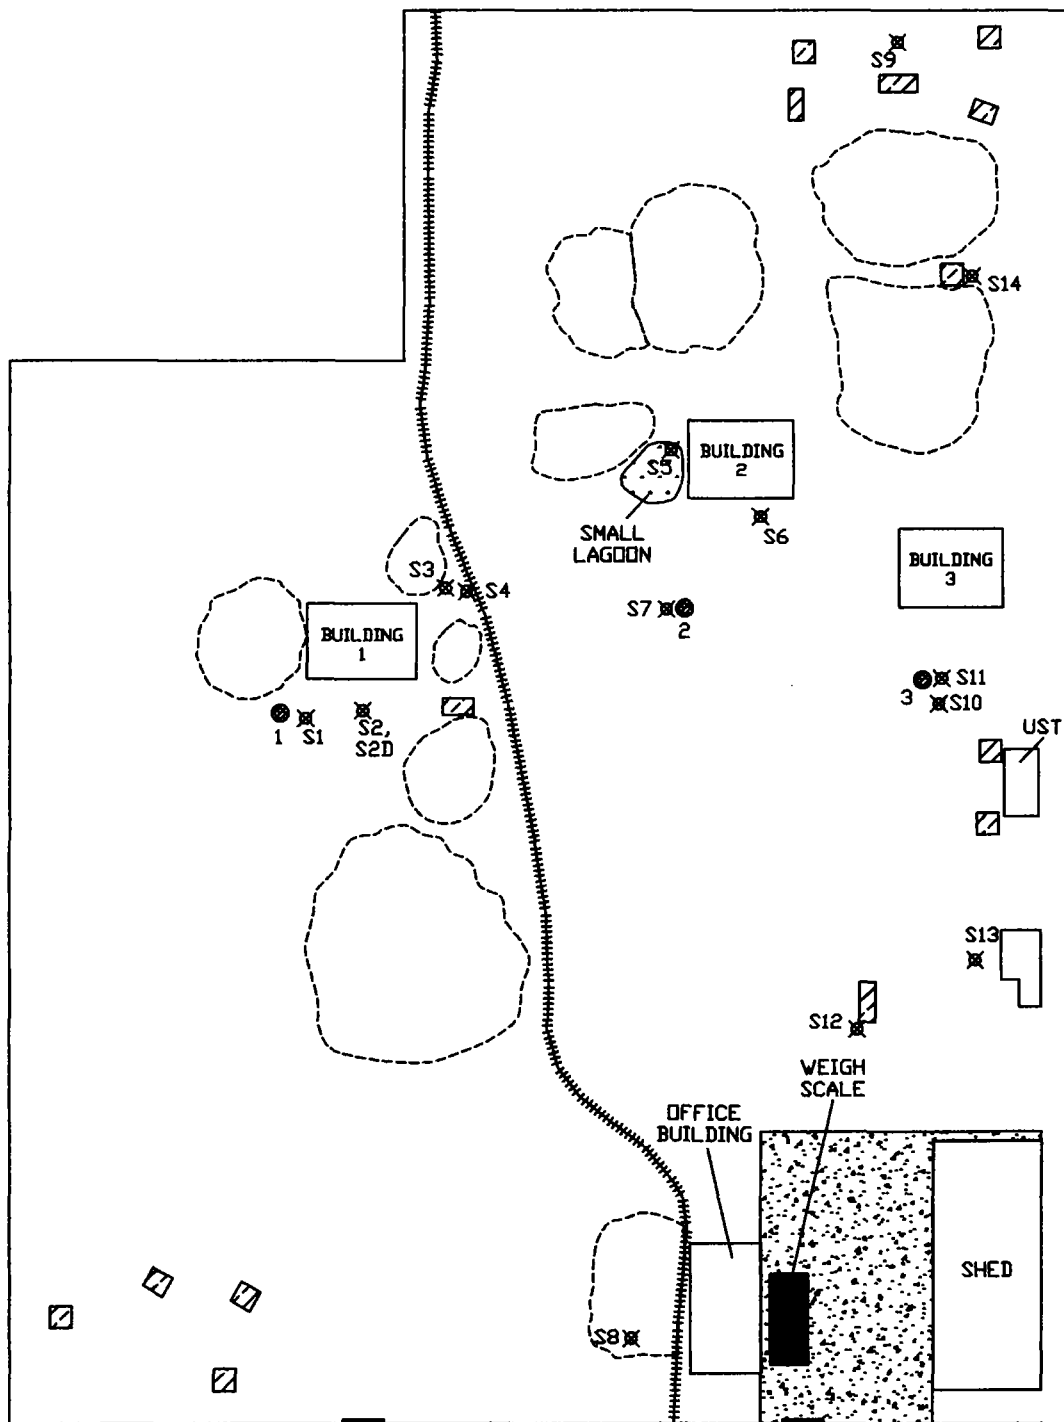
FIGURE 5
YARD 1 SOIL SAMPLING LOCATIONS

Sample No.	Date	Time	Description
S1	11 Sep 01	1415	Black stained soil northeast of Transformer Pole 1
S2	11 Sep 01	1420	Black stained soil southeast of Building 1
S2D	11 Sep 01	1420	Duplicate of Sample No. S2
S3	11 Sep 01	1432	Lowest point near northeast edge of the pile of insect repellent spray cans to be analyzed for pesticides
S4	11 Sep 01	1437	Sludge on the southwest side of the railroad tracks just northeast of Sample No. S3
S5	11 Sep 01	1442	Sludge on the northern edge of lagoon near Building 2
S6	11 Sep 01	1450	Black stained soil on the southeast side of Building 2
S7	11 Sep 01	1521	Southwest of Transformer Pole 2
S8	11 Sep 01	1529	Scrap pile (assumed to be aluminum scrap) located southwest of office building
S9	11 Sep 01	1535	Fluff material located near north corner of Yard 1
S10	12 Sep 01	0910	Black stained soil east of Transformer Pole 3
S11	12 Sep 01	0913	Black stained soil northeast of Transformer Pole 3

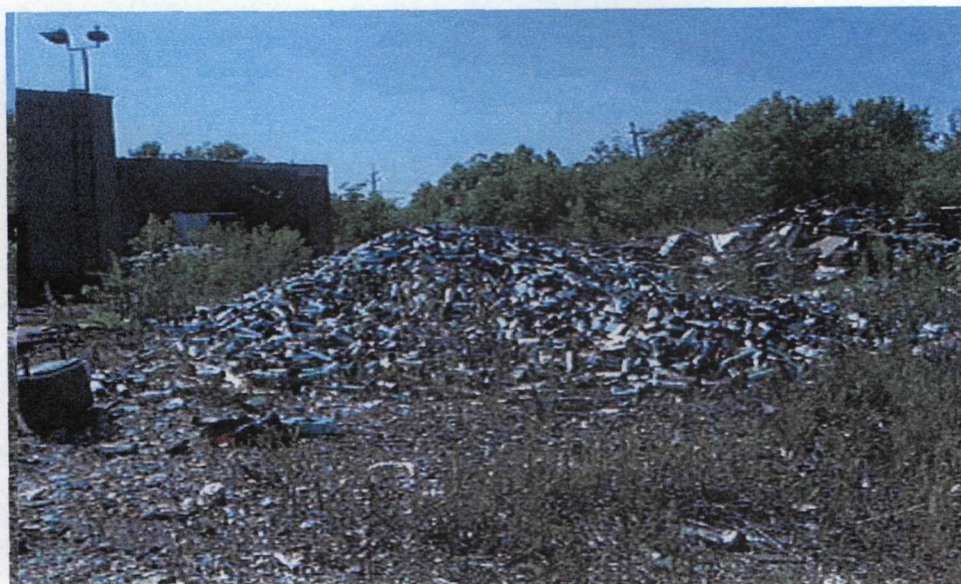
Photograph No.: 1
TDD Number: S05-0108-036
Location: Lefton Iron & Metal (Yard 1)
Subject: Pile of cans near Sample No. S3 location

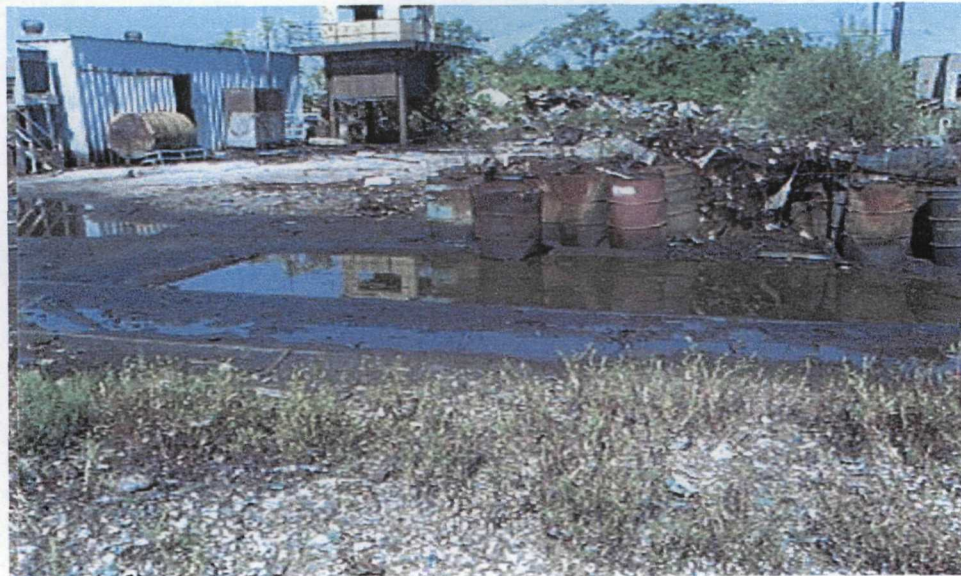
Photograph No.: 2
TDD Number: S05-0108-036
Location: Lefton Iron & Metal (Yard 1)
Subject: Sludge near railroad tracks at Sample No. S4 location

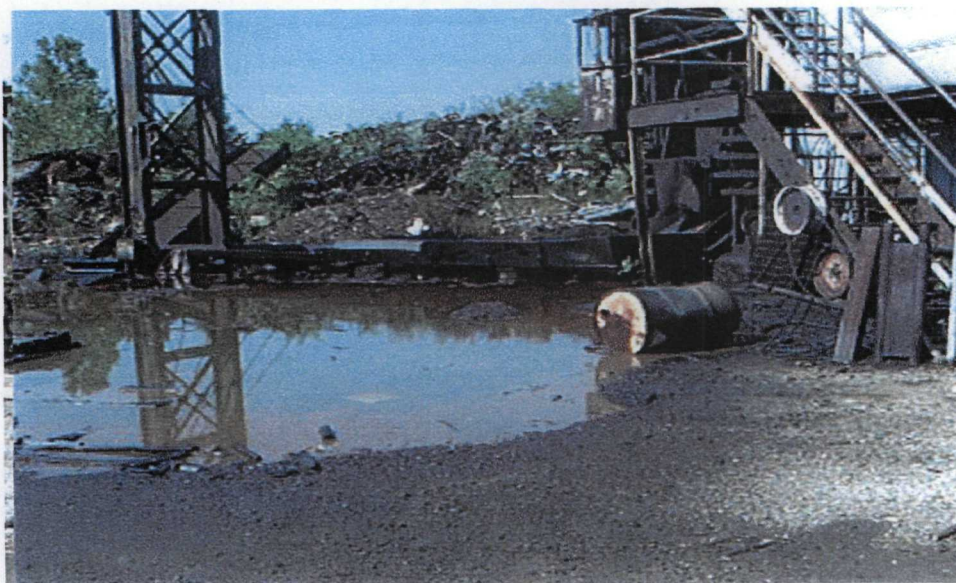
Photograph No.: 3
TDD Number: S05-0108-036
Location: Lefton Iron & Metal (Yard 1)
Subject: Lagoon at Sample No. S5 location

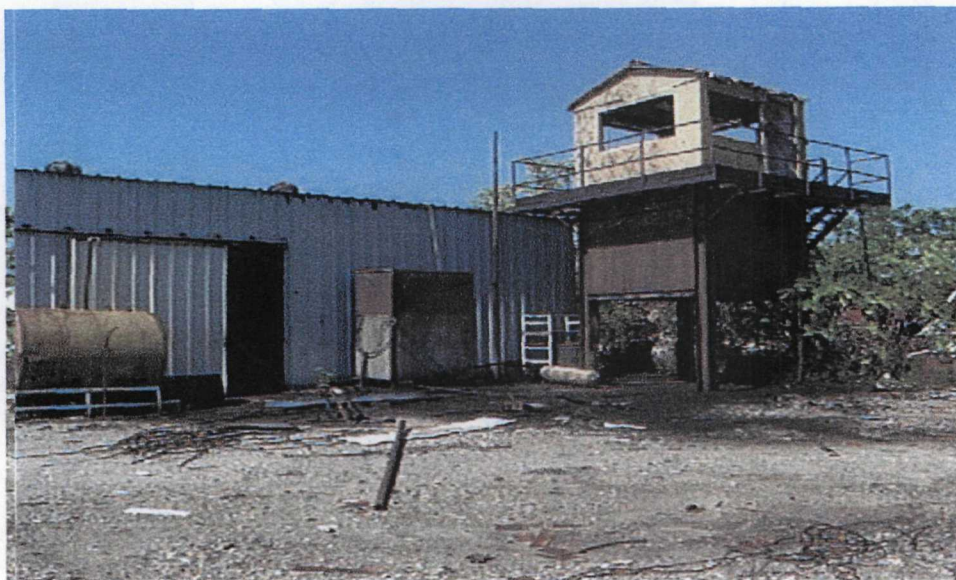
Photograph No.: 4
TDD Number: S05-0108-036
Location: Lefton Iron & Metal (Yard 1)
Subject: Building 2 near Sample No. S6 location

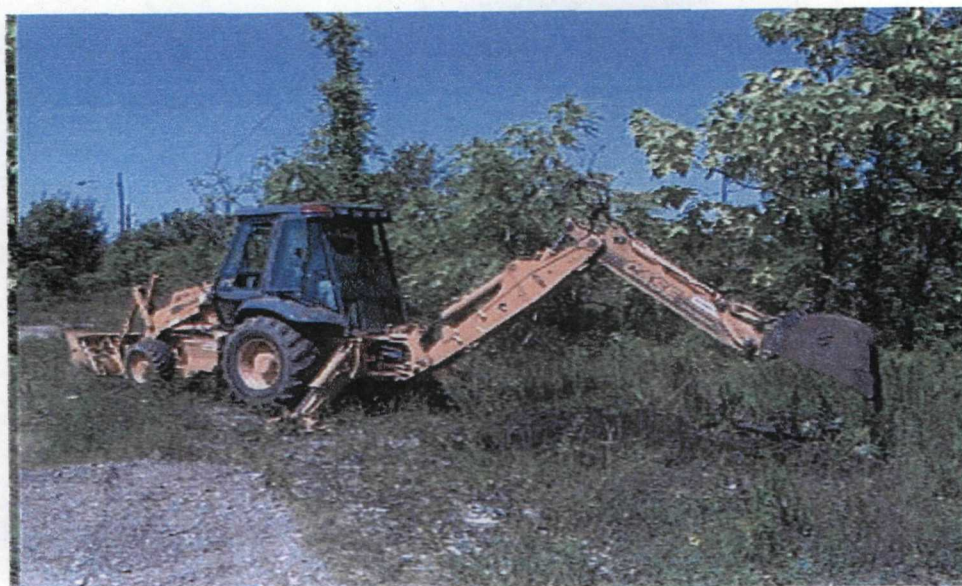
Photograph No.: 5
TDD Number: S05-0108-036
Location: Lefton Iron & Metal (Yard 1)
Subject: Pit Excavation 3

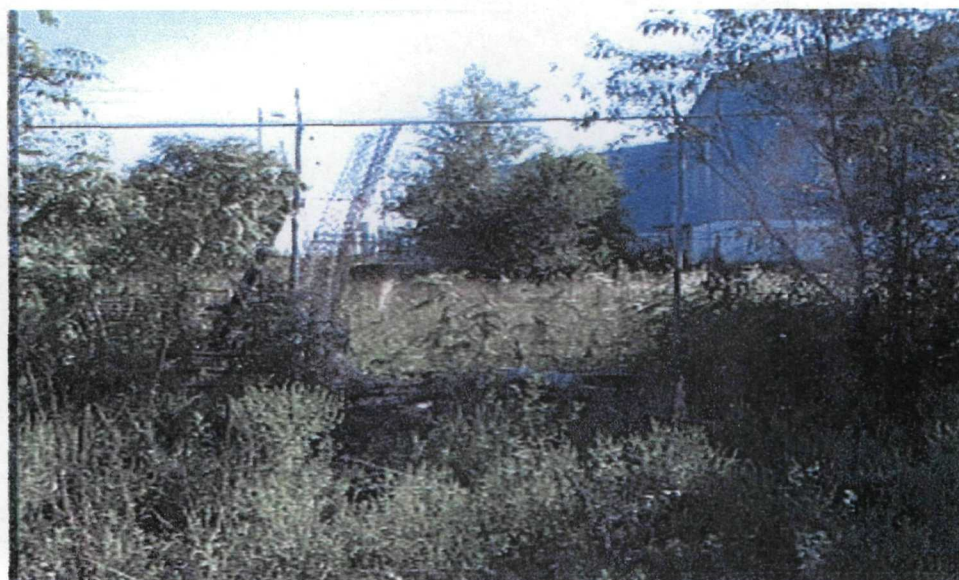
Photograph No.: 6
TDD Number: S05-0108-036
Location: Lefton Iron & Metal (Yard 1)
Subject: Breach in northeast fenceline

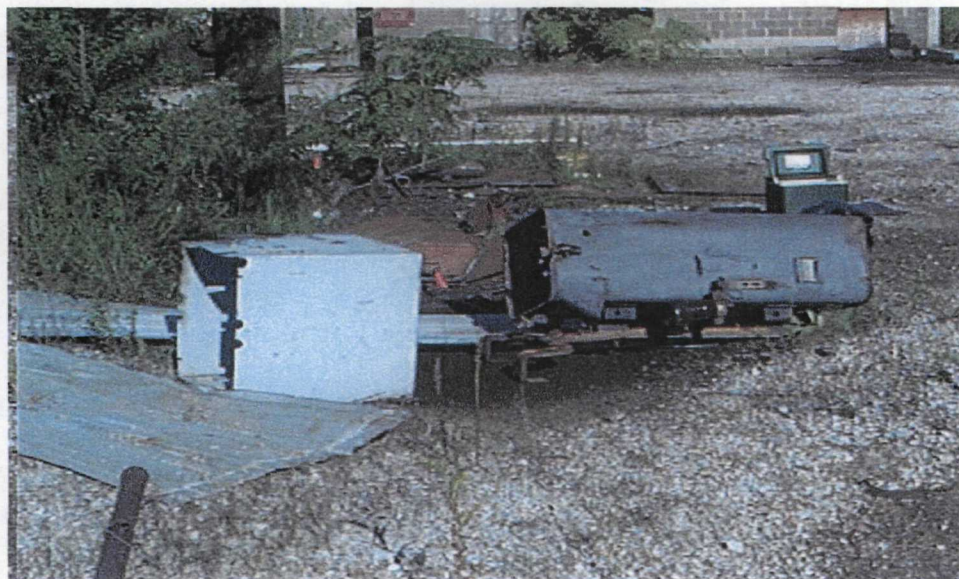
Photograph No.: 8

Subject: Stained soil near transformer pole at Sample No. S10 location

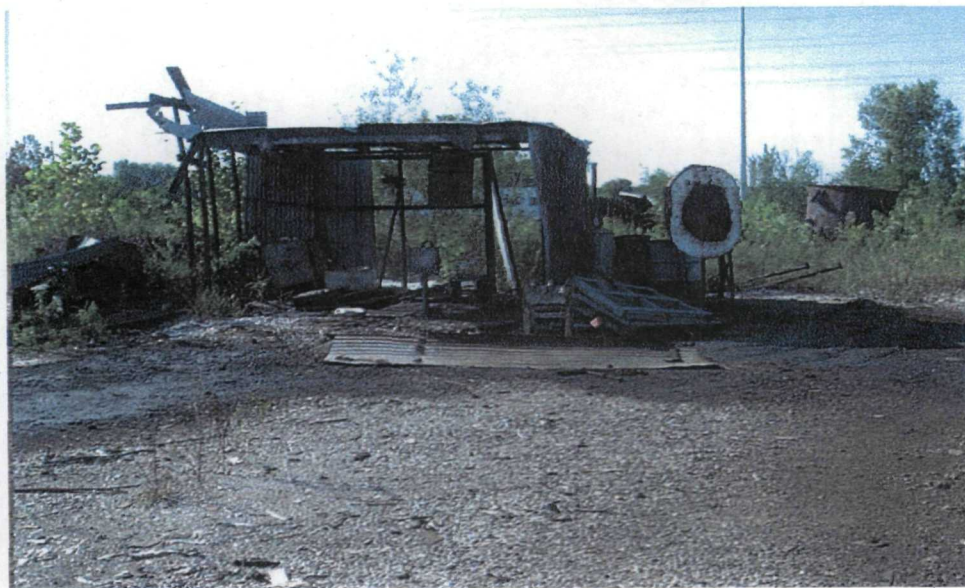
Photograph No.: 9

Subject: Shed and stained soil near Sample No. S16 location
